Ouzinkie Health Clinic

Alaska Rural Primary Care Facility

Assessment and Inventory Report

February 24, 2004

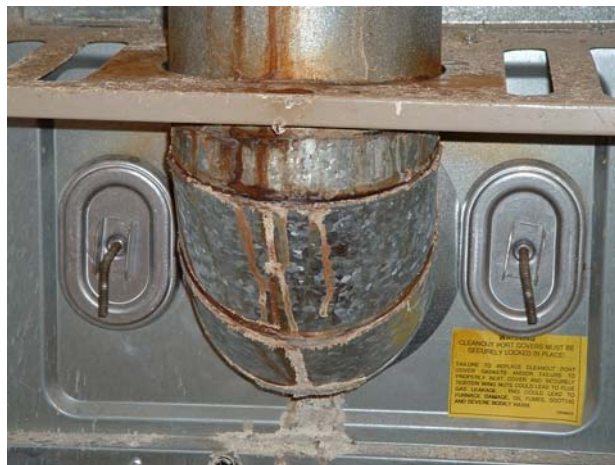
Mou12	05	Outside air duct terminates in attic.	Extend duct to louver on exterior wall.
Mou13	05	No balancing dampers on return or outside air ducts.	Provide dampers.
Mou14	05	No filter in furnace system.	Install filters in return air.
Mou15	01	Furnace flue corroded.	Replace with double-wall flue.
Mou16	01	Flue clearances to combustibles not maintained.	Replace with new flue, installed per manufacturer's requirements.

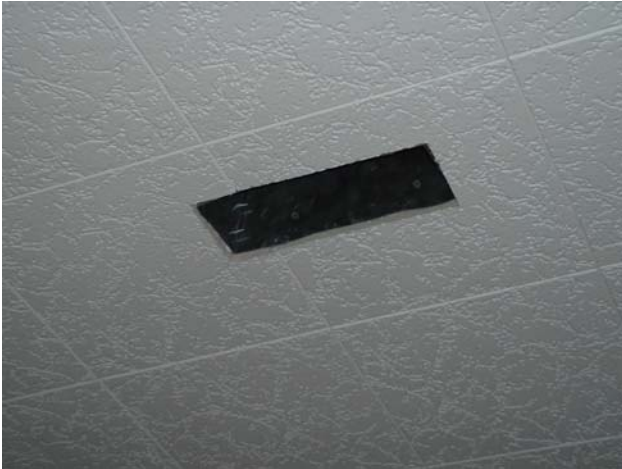
Mou17	05	Furnace combustion air inadequate.	Provide additional exterior opening per IMC requirements.
Mou18	05	Ceiling grille missing in storage room.	Provide grille.
Mou19	05	Supply air in cold attic is un-insulated.	Insulate ductwork.
Mou20	05	Janitor exhaust fan not ducted to exterior.	Route duct to exterior.
Electrical Deficiencies

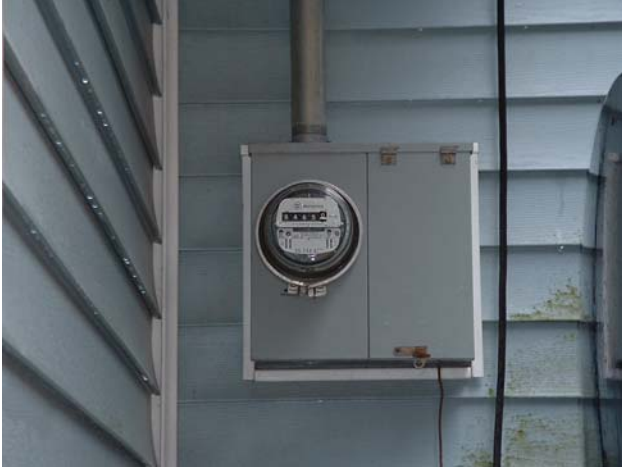
Eou01A

Item #	Code	Deficiency	Suggested Resolution
Eou01	01	Separation of electrical disconnect from fuel tank inadequate.	Relocate fuel tank.
Eou02	06	Grounding and neutral bus bars tied together.	Re-wire panel to connect ground wires to ground bus bar.
Eou03	06	Clearance in front of electrical panel is inadequate.	Relocate clothes washer/dryer.
Eou04	06	NM (Romex) cabling used in patient care areas.	Replace NM cable with wiring routed in conduit.
Eou05	06	Junction boxes in attic missing covers.	Provide covers.
Eou06	06	Quantity of receptacles inadequate.	Provide additional receptacles where needed.
Eou07	01	Emergency light missing.	Replace missing light and provide an additional emergency light.

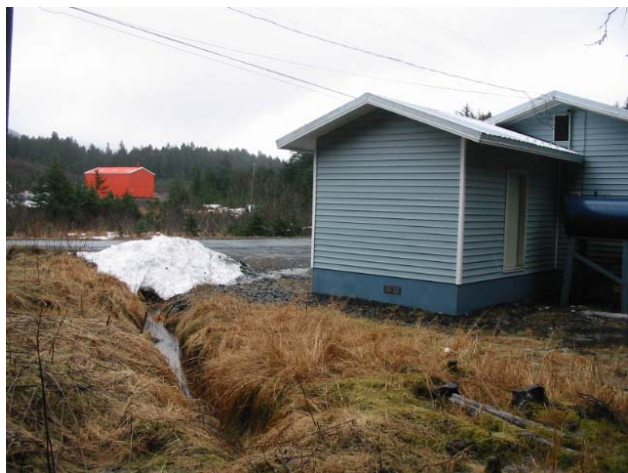
CGE01
Drainage Ditch at North Edge of Property

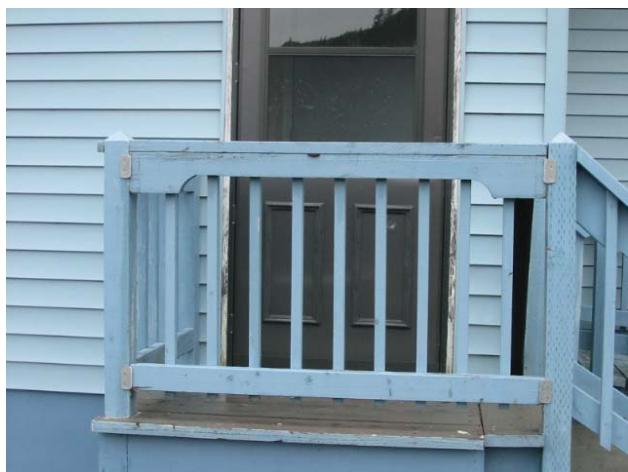
AGE11
Main Entry & Typical Landing/Stair Construction
